GLOBAL EARTHQUAKE MODEL 2018 A Step Toward Earthquake Resilience

5th of December 2018 | 0900h - 1800h | CAR College, Pavia, Italy

## IMPACTS AND LESSONS FROM THE RECENT INDONESIAN EARTHQUAKE IN LOMBOK AND PALU 2018

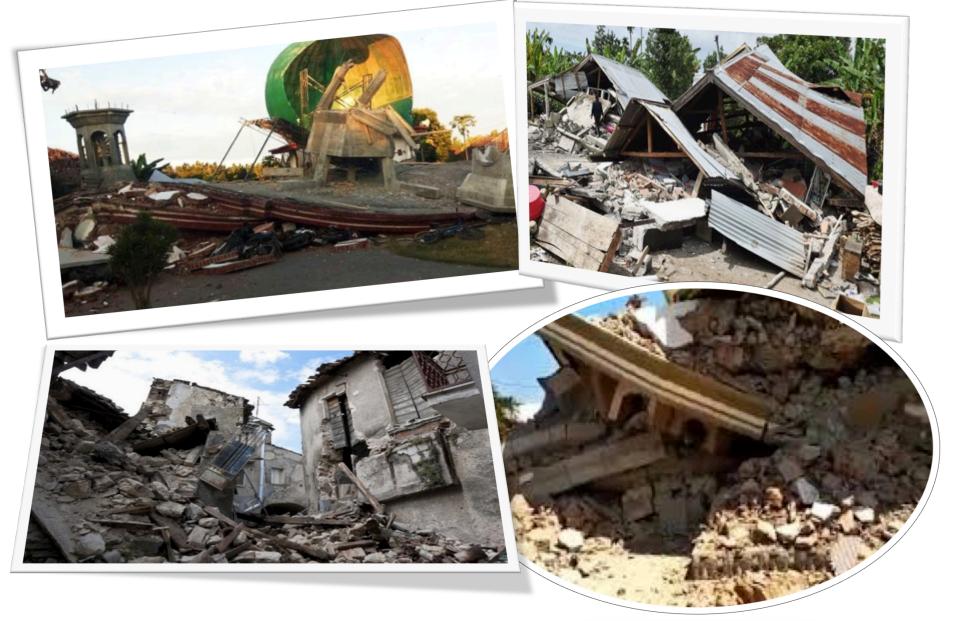
### Buildings Collapse Lombok Eq. 2018

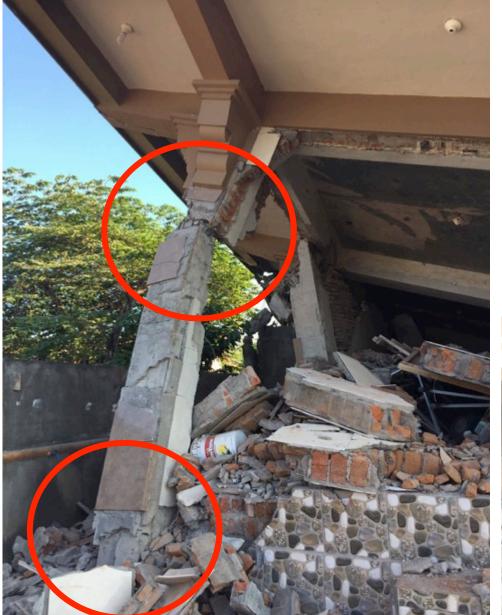
### "STRONG COLUMN WEAK BEAM" CONSEPT NOT YET APPLIED

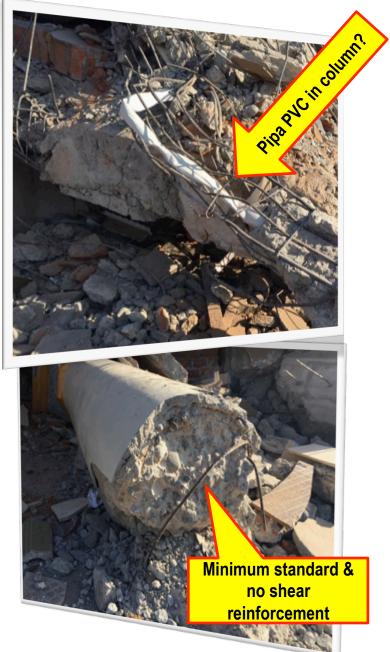
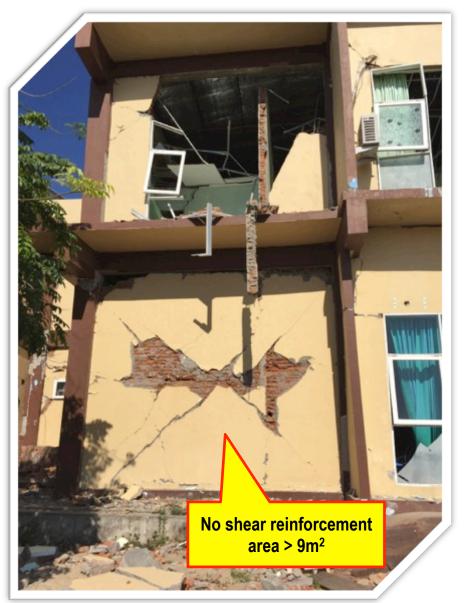
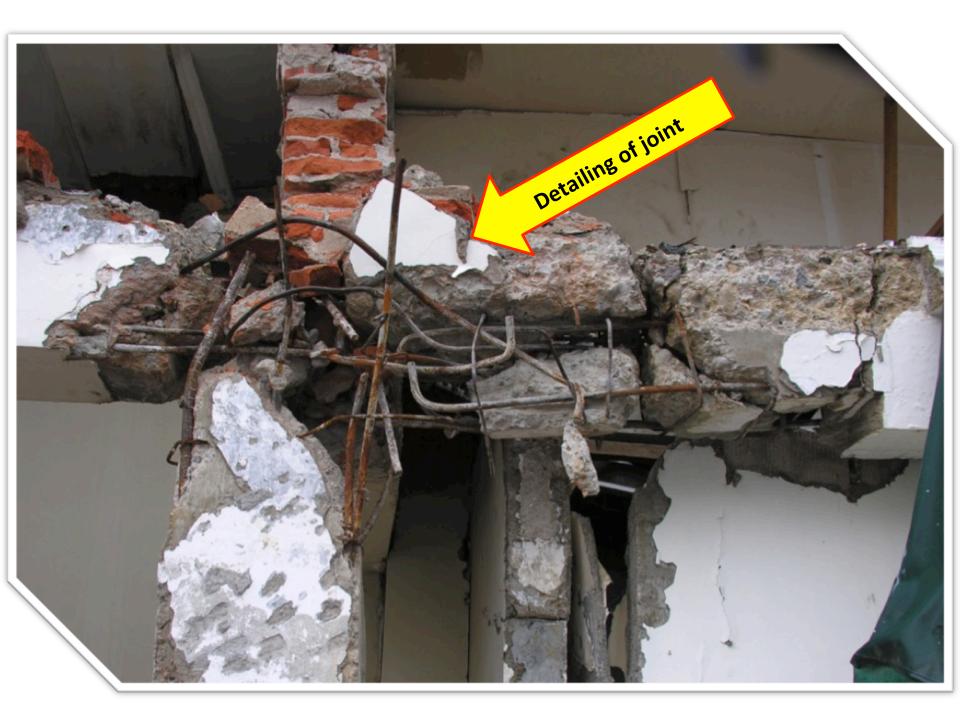
### **MINIMUM STANDARD OF REINFORCEMENT**

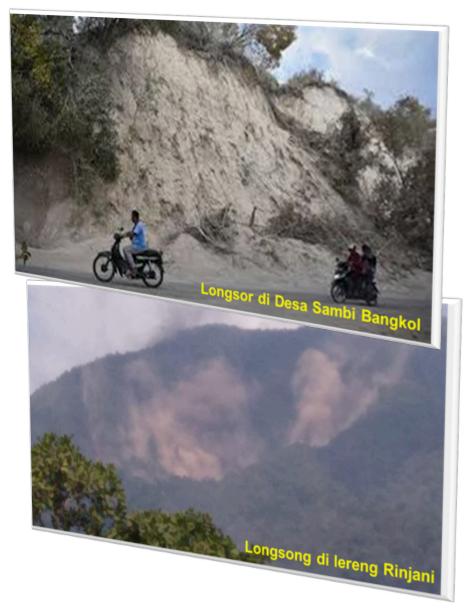
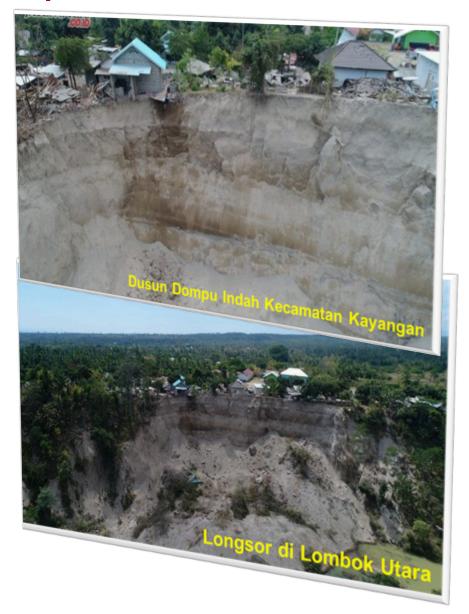
## LANDSLIDE Lombok Eq. 2018

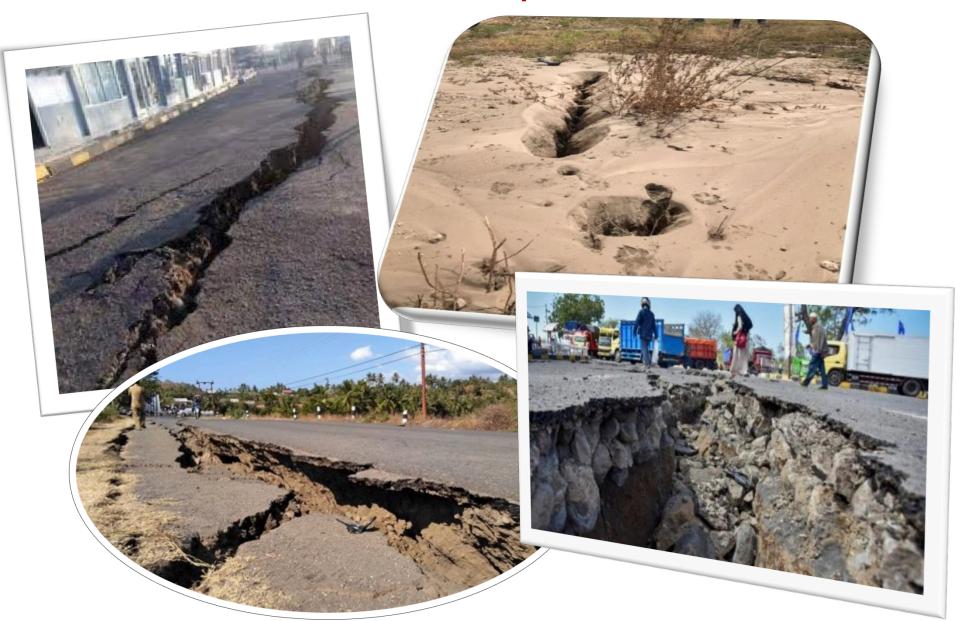
## LIQUIFACTION & GROUND CRACKING Lombok Eq. 2018

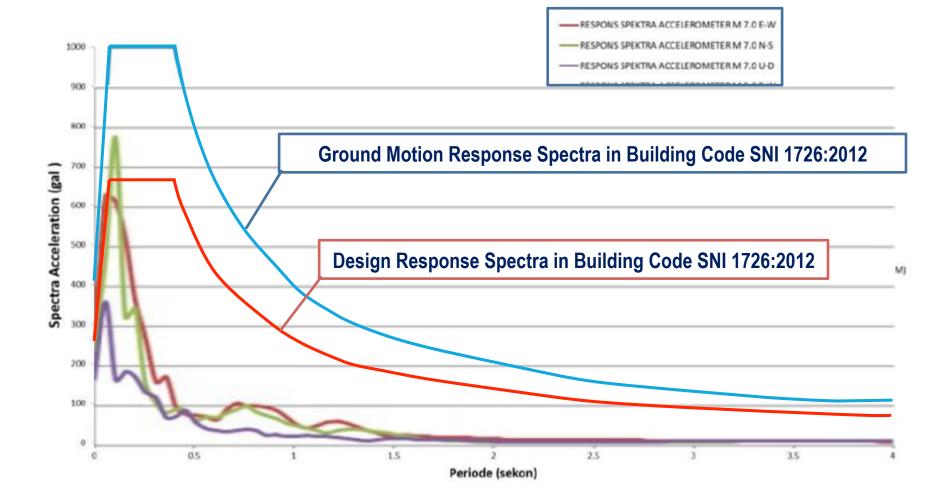
#### Design and Recorded Response Spectra at Geophysics Taliwang Station M 7.0 Lombok Earthquake 2018

VII MMI scale → converted to PGA about 0.18-0.34g (Actual G Motion)

Indonesian Risk Map (MCE<sub>G</sub>) SNI 1726:2012 for Lombok  $\rightarrow$  0.4-0.5g (bedrock)

In fact  $\rightarrow$  many buildings that have structural damage (from medium to heavy), even to collapse due to the earthquake that occurred

**→** Buildings not designed in accordance with seismic design standards

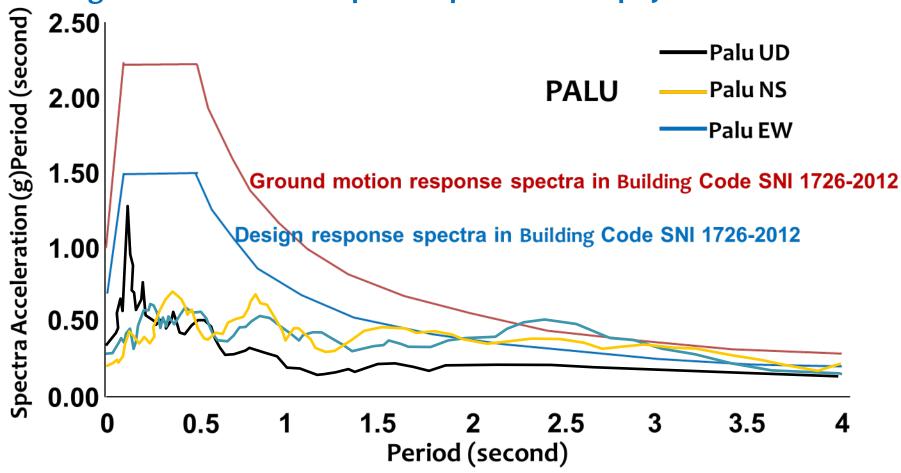
**Design and Recorded Response Spectra at Geophysics Station of Palu**

Same case with Lombok Eq

PALU EQ → Actual GM < Design GM → but, many buildings collapse

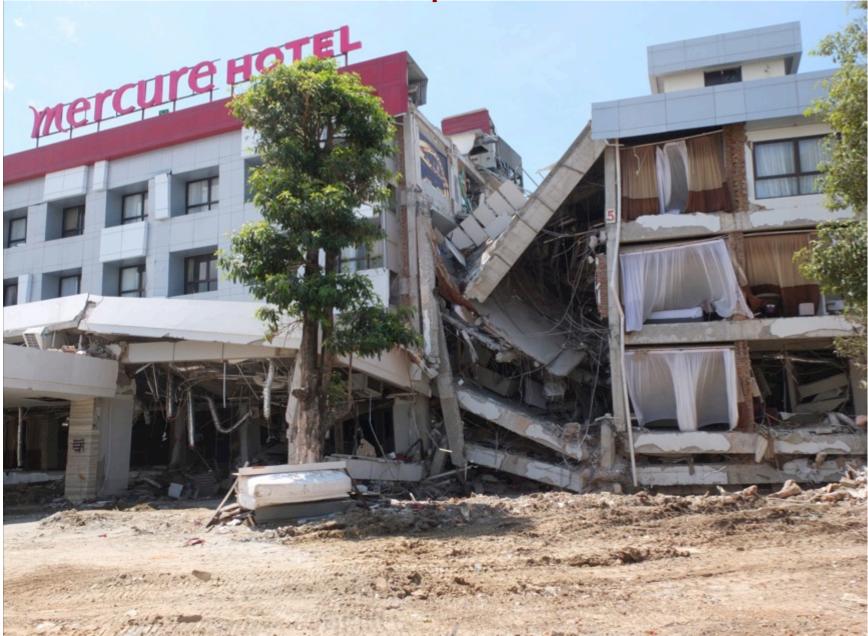
## BUILDINGS COLLAPSE Palu Eq. 2018

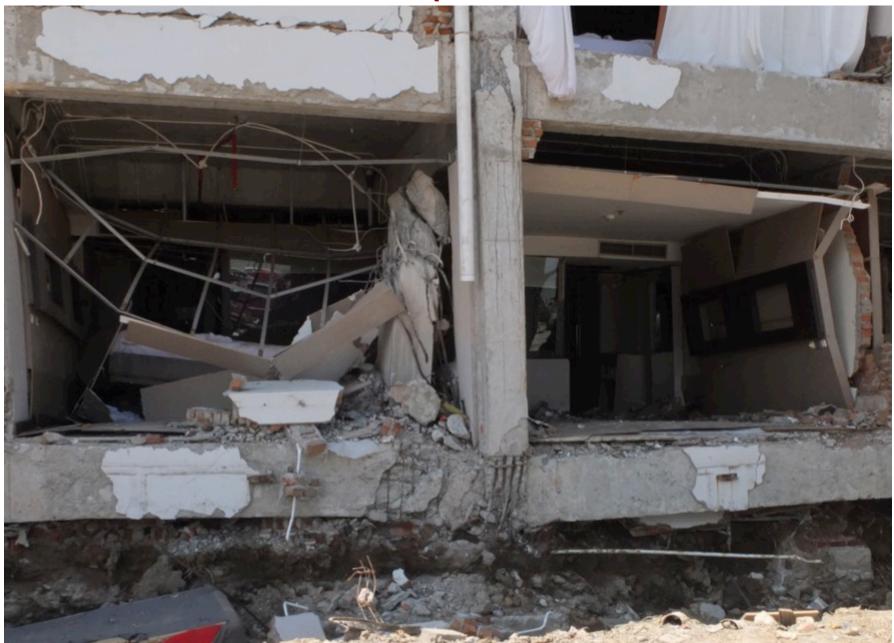
## BUILDINGS COLLAPSE Palu Eq. 2018

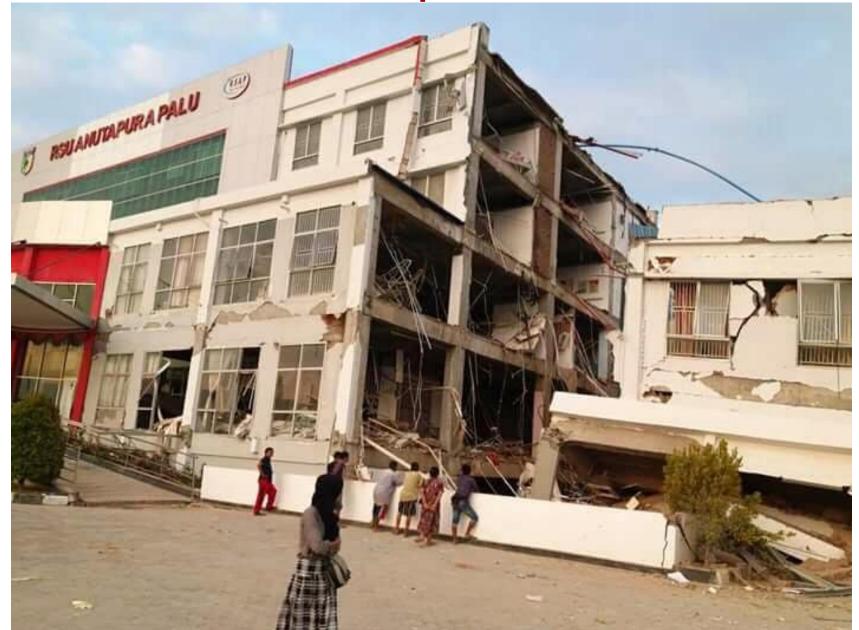
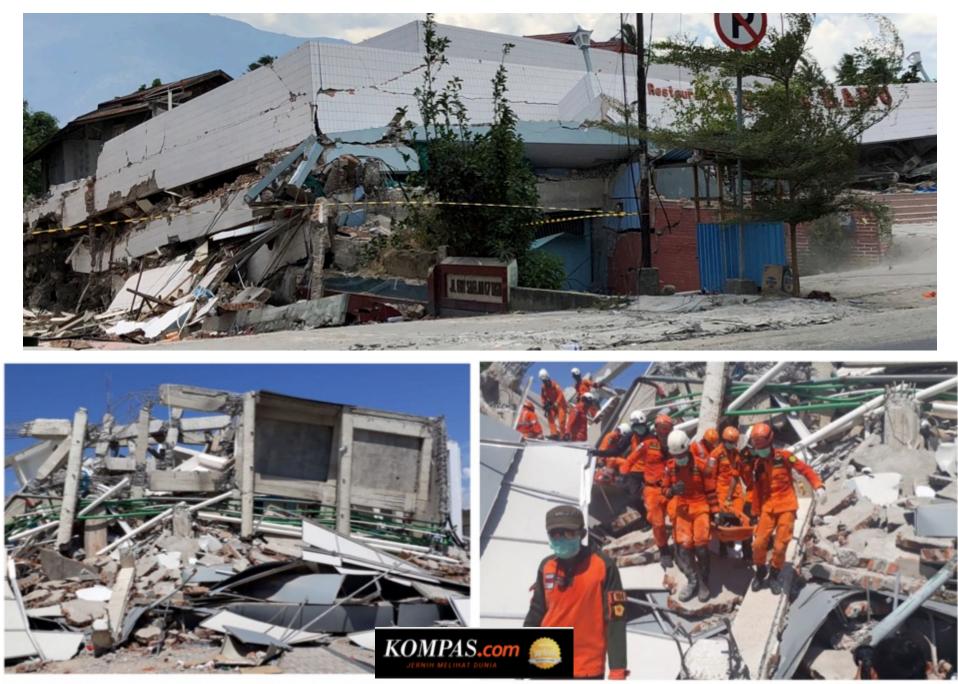
## DAMAGE & LIQUIFACTION Palu Eq. 2018

Hotel Roa Roa di kawasan Maesa di Kelurahan Lolu Timur, Kota Palu, luluh lantak dihantam rangkaian gempa yang melanda Sulawesi Tengah. Puluhan tamu belum diketahui nasibnya. (KOMPAS.com/ROSYID A ATLAN)

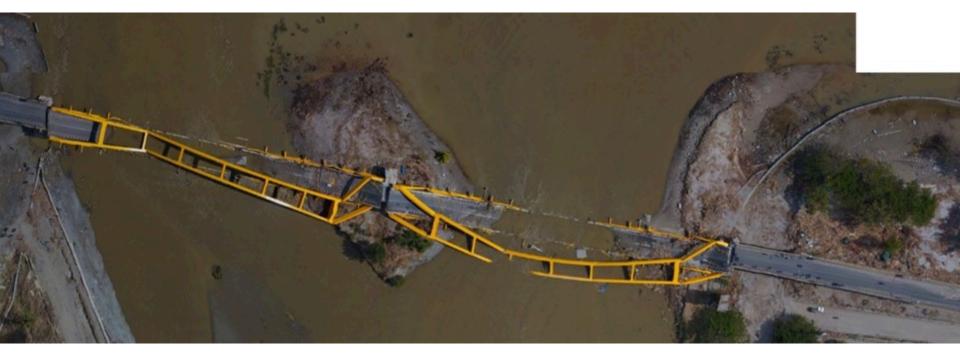
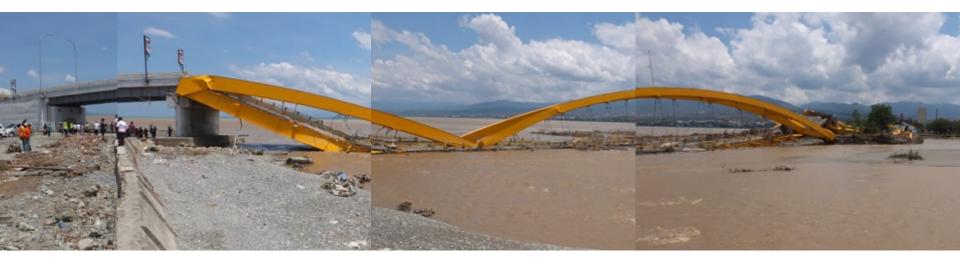
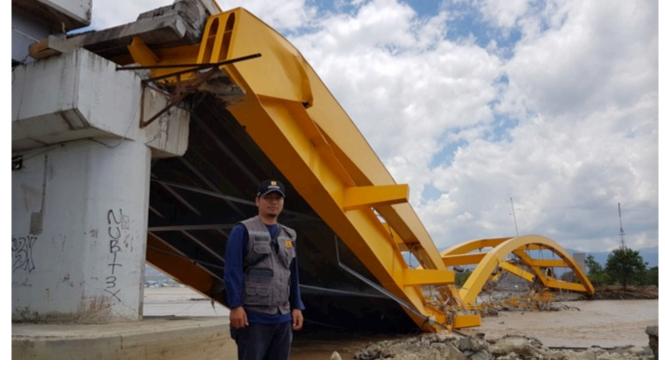
## **BRIDGE COLLAPSE**

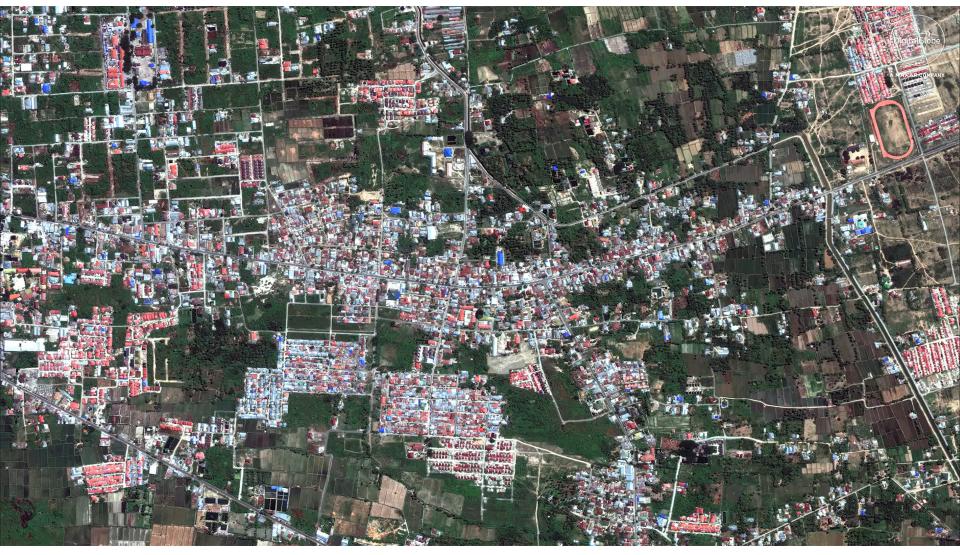
## **Flow Liquefaction Failure**

## Petobo village (Youtube, 2018)

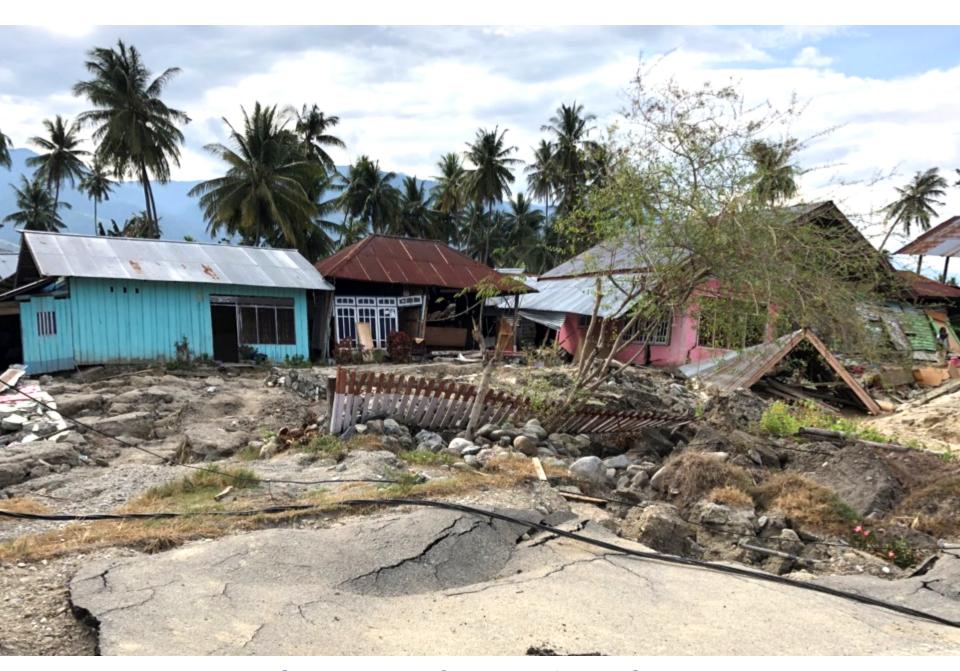
## Houses have moved approximately 400m

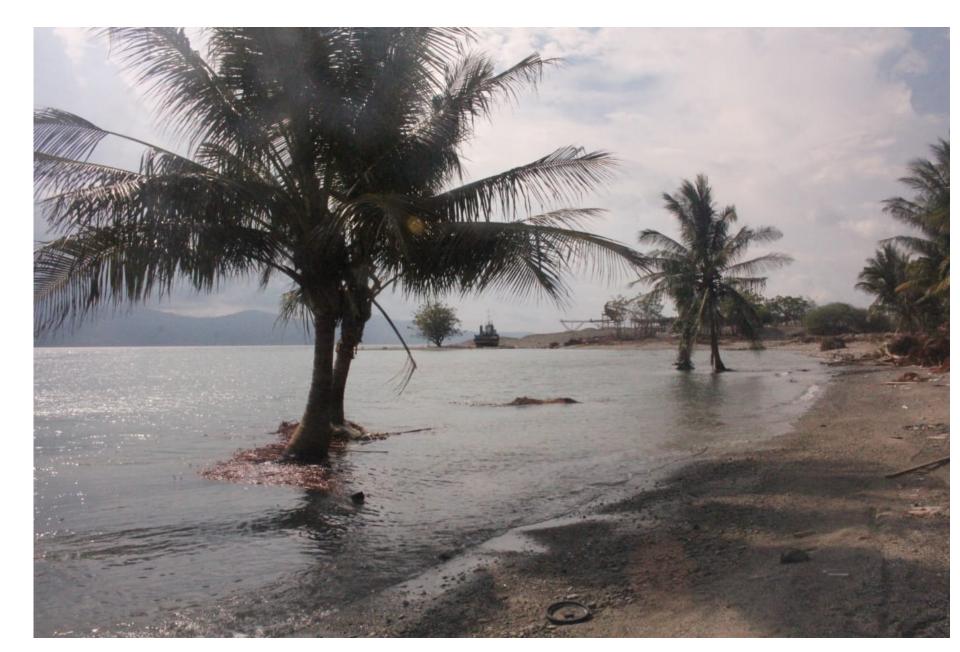
## LAND SUBSIDENCE
