GLOBAL EARTHQUAKE MODEL 2018 A Step Toward Earthquake Resilience

5th of December 2018 | 0900h - 1800h | CAR College, Pavia, Italy

## IMPACTS AND LESSONS FROM THE RECENT INDONESIAN EARTHQUAKE IN LOMBOK AND PALU 2018

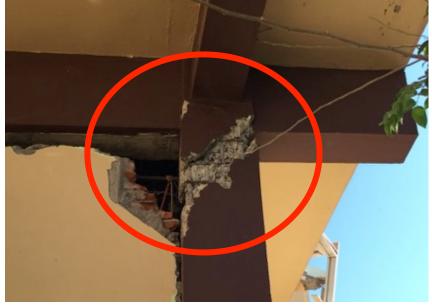
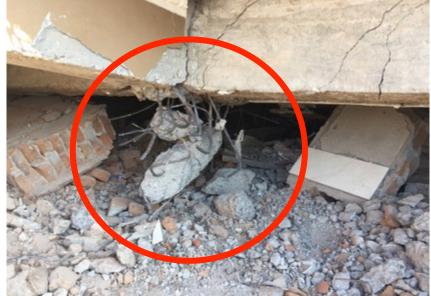
### "STRONG COLUMN WEAK BEAM" CONSEPT NOT YET APPLIED

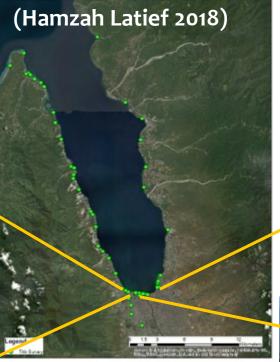
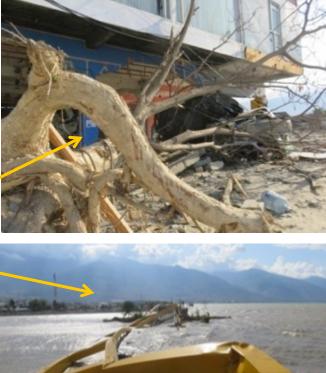
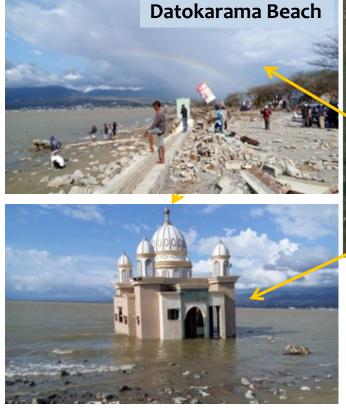
Wood and car transported by Tsunami

Mosque in front of the Gas Station

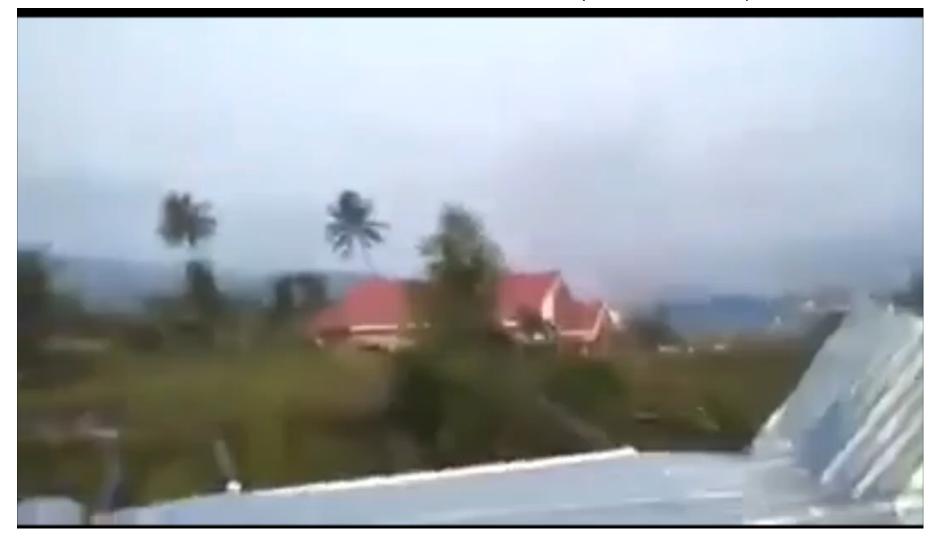
## Jono oge village (Youtube, 2018)

## Ground Cracking, Jono oge village

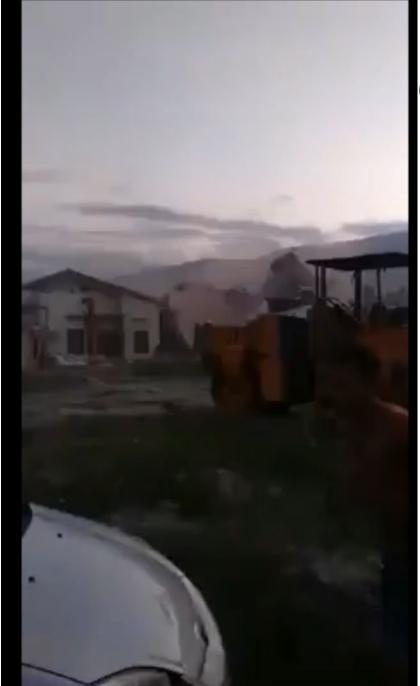
# Petobo village (Youtube, 2018)

## **Soil Condition & Liquefaction**

## **Flow Liquefaction Failure**

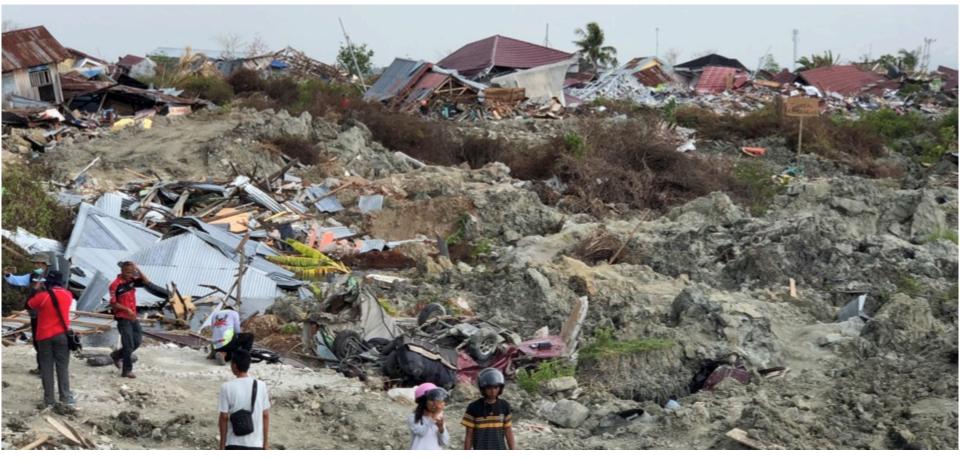
#### Toe of failure

(e) Rotational and/or Translational Sliding
